ReClam Shellbag Report – December 2018

This Project –

RCTB has been assisting the Mordecai Island Land Trust (MILT) in the development of methods to control erosion and to restore the diverse habitat on Mordecai Island in Beach Haven, New Jersey. The island is located adjacent to the Intercoastal Waterway (ICW) and has been subjected to erosional factors as result of wave action and increased boat traffic over the years. The Army Corps of Engineers (USACOE) utilized the island in 2015 in a Beneficial Use Project to reconnect the eroded north and south islands. In 2017 the USACOE placed additional material from the ICW on the site to control the erosion (Figure 1).

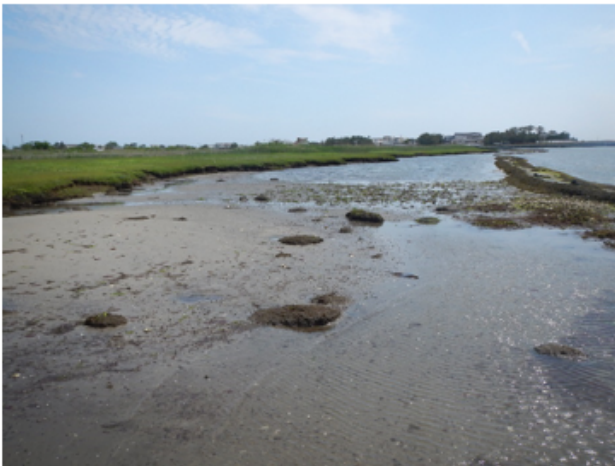
shellbags (Photograph 2). There has been accumulation of sand behind the GeoTube and it has provided a surface for oyster habitat. The problem is that the area is subjected to removal by ice (Photographs 3 & 4). A total of 13 species were identified from the shellbags but mud snails and limy tubeworms were not recorded in these samples. Natural set oysters were recorded in the sample.

Photograph 3: The accumulated sand created an intertidal habitat between the GeoTube and Mordecai Island.

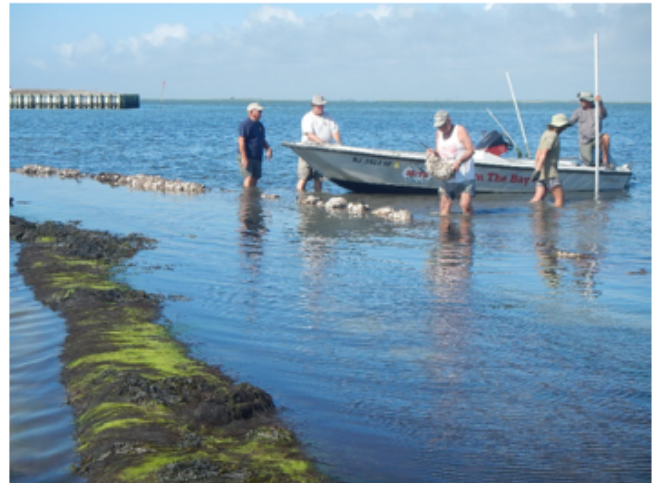
Location 1 Figure 1: The shellbags were placed in front of the GeoTube in 2016 for additional protection and to provide a location to assess the accumulation of sediments. Shellbags placed in this location did create a living shoreline. The bottom shellbags are completely covered with sediments and trapped several species [e.g. Eelgrass (*Zostera marina*, (SAV) submerged aquatic vegetation) and sea lettuce (*Ulva lactuca* – macro algae) (Photograph 1) The elevation of the shellbag pile was raised to the GeoTube height in 2018 by adding shellbags on top of the existing

Photograph 2: July 2018 – Shellbags were placed on top of the old shellbags, elevating them to the height of the GeoTube to provide an intertidal living shoreline habitat.

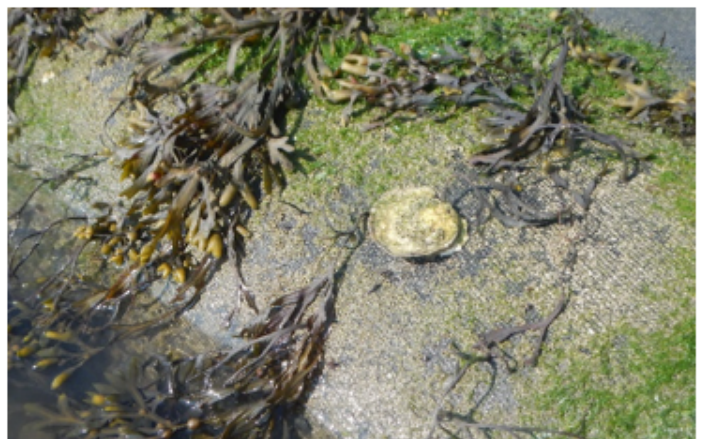
Photograph 4. Oyster attached to the GeoTube along with rockweed (*Fucus spiralis*) and sea lettuce (*Ulva lactuca*).

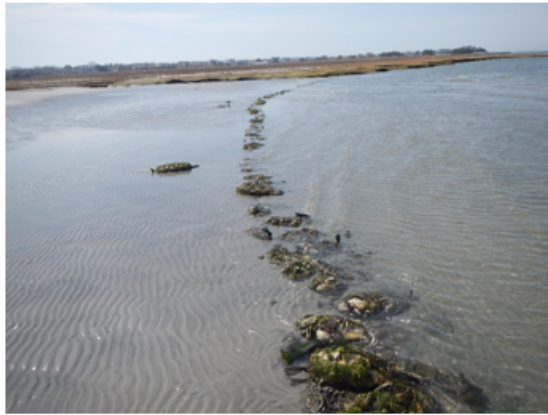
Location 2, Figure 1: A shellbag barrier was constructed in 2016 with additional shellbags placed on top of the 2017 shellbags. (Photographs 5 & 6). The lower shellbag rows are completely under sand (Photograph 7). Sampling identified 16 species, but mud snails and limy tubeworms were not recorded in the sample. Natural-set oysters were recorded in the sample.

Photograph 6: This sample location is at the southern end of the shellbag barrier. It shows a second layer of shellbags placed on the barrier in the fall of 2017. The lower level of bags, covered in sediment, were sampled. (Photograph 4/17/18). The shellbags were subjected to three major storms and ice over the winter of 2018. Only one or two of shellbag were dislocated.

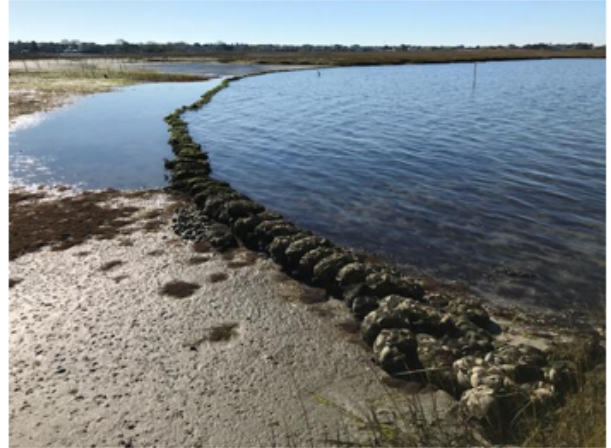
Photograph 5: The shellbag barrier constructed for sand retention and living shoreline creation is three shellbags high. (Photograph taken 10/17)

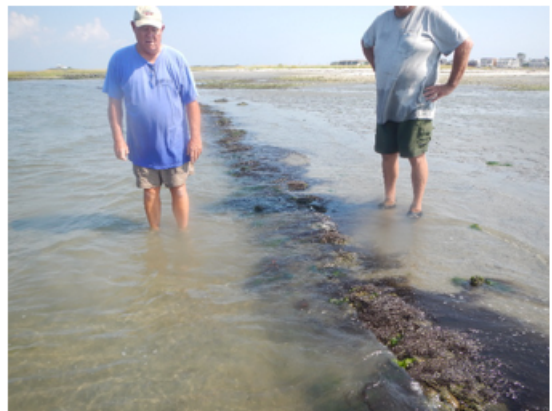
Photograph 7: Sampling location 2 shows the sedimentation collected over the winter of 2017-18. Bags were put down in the fall of 2017. The living shoreline is cover with some un identified SAV and macro algae. Sampling documented the creation of an intertidal habitat. Note the difference in water level. Volunteer in blue is mid-calf. The other volunteer is just ankle deep.

Note the difference in bay floor elevation. (Photograph 7) The volunteer in blue on the left is mid calf where the one on the right is just to the top of his shoes.

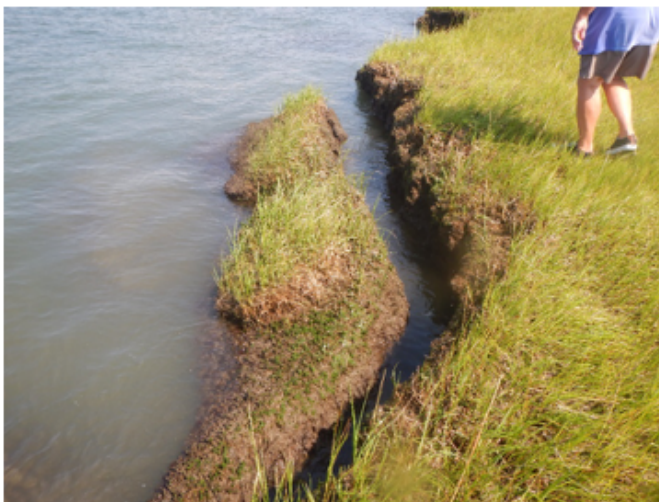
Photograph 8: The erosion below the spartina root and ribbed mussel habitat allow for the marsh edge caving.

Location 3: The shellbags were placed at the base of The marsh edge where wave action was cutting under the salt marsh cordgrass (*Spartina alterniflora*) roots and ribbed mussel (*Geukensia demissa*) community. (Photograph 8). The objective was to decrease the erosion and provides a living shoreline habitat, was met.

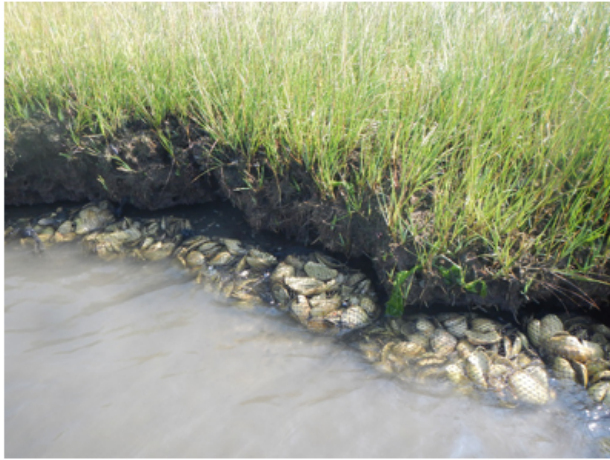
Photograph 9: Location 3 displays shellbag placement at the base of the eroded marsh face which is located at the mid-intertidal elevation.

Shellbags were assessed for colonization after only two months of emersion. (Photograph 9). Natural-set oysters were identified in all three sampled shellbags along with a large number of limy tubeworms and mud snails (Table 2). Bags placed in an area to reduce erosion was effective. A small beach was created and colonized by *Spartina alterniflora* (Photograph 10).

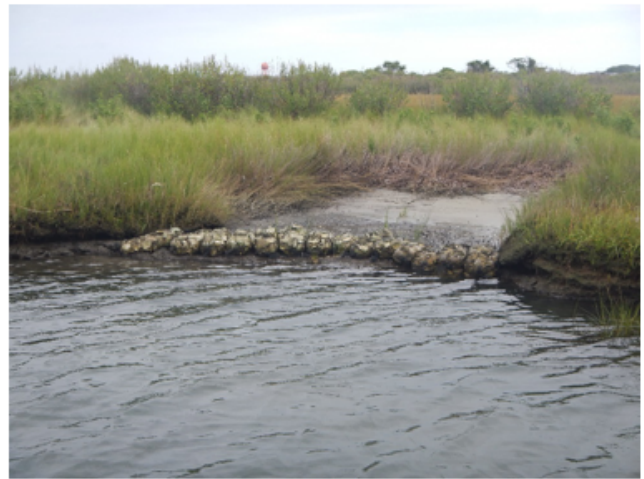
Photograph 10: Two months after the placement of the shellbags, there is an accumulation of sediment and a diverse intertidal community behind the shellbags. *Spartina* is starting to grow between the shells.

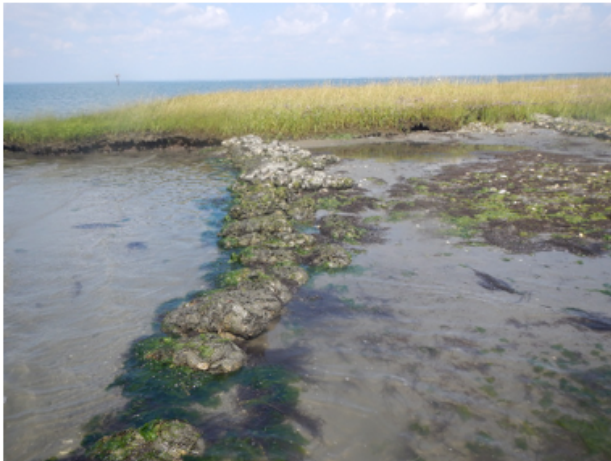
Location 4: The shellbags were placed at the northern end of the barrier in the intertidal habitat (Photograph 11).

Photograph 11. Sampling location 4 is at the lower barrier location of the shellbags. This is a diverse intertidal habitat that includes unidentified SAV and macro algae. This habitat is above the mid intertidal elevation as in photograph 10 - 9/6/18
